It is time for the problem of pump corrosion and consequent failure to be eliminated

Type: Long Paper (up to 6,000 words)

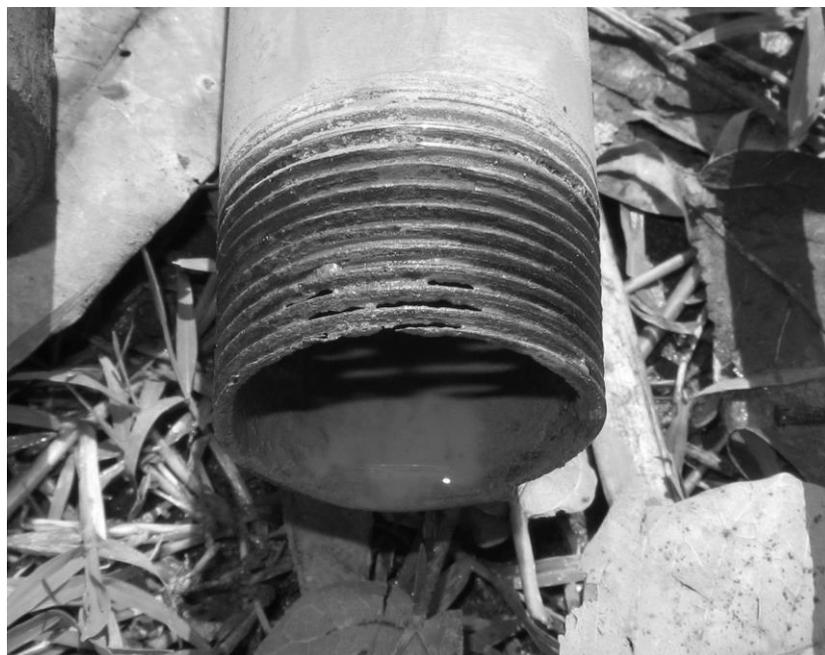
Following the tests, the riser pipes on some of the handpumps were pulled to allow inspection for signs of corrosion. Evidence of corrosion was seen at all the sites, in particular at Odengelo village where the

riser pipe was found to be leaking. The threads on some pipe joints at this handpump were severely damaged (Figure 2) and also indicated the use of sub-standard material. This borehole was only completed in October 2013 and the pump installed in December 2013, indicating how rapidly corrosion can affect a handpump under certain groundwater conditions.

Figure 2 Threads on riser pipe at Odengelo, 1 year after installation

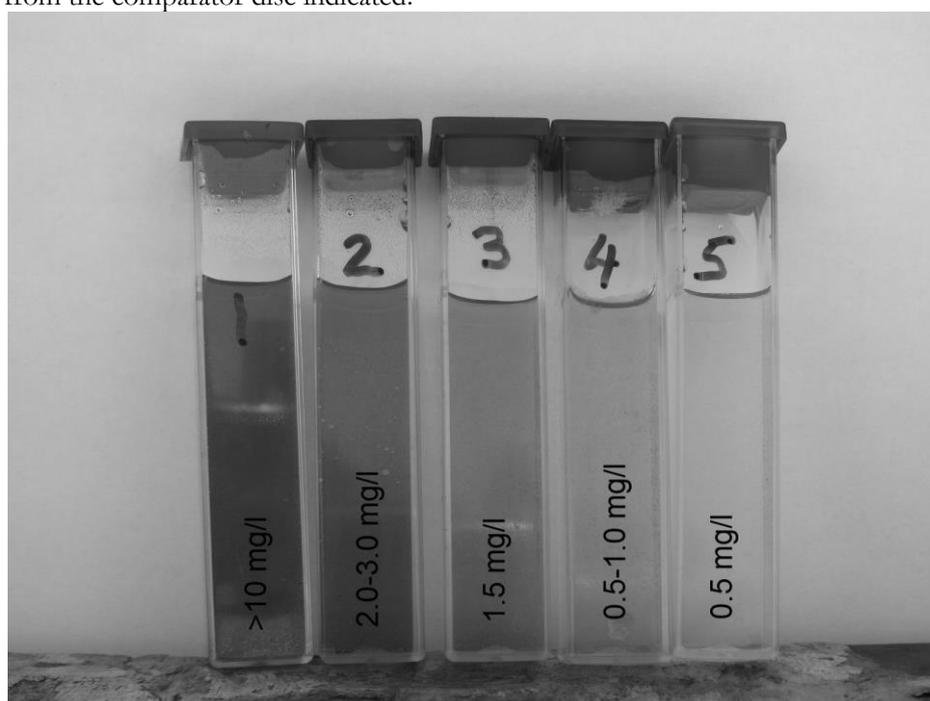
The results from the field analysis using the Palintest kit show a clear colour change from deep red (sampled from riser pipe) to light orange at the end of the test, indicating a decline in iron concentration. An example from the test at the Odengelo borehole is shown on Figure 3 with the iron concentrations interpreted from the comparator disc indicated.

Figure 3. Results of Palintest analysis at Odengelo handpump with GI riser

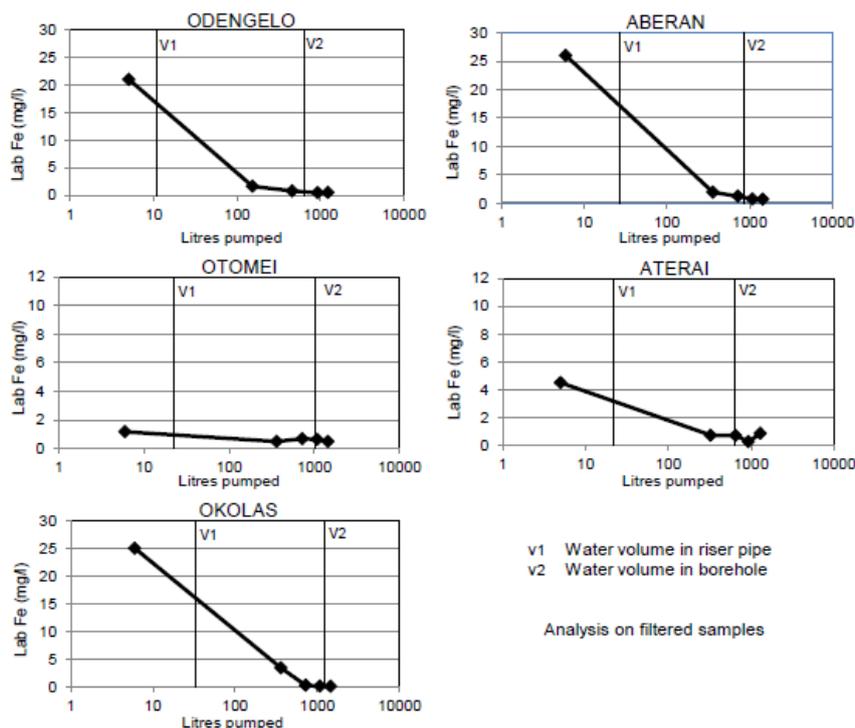
pH values in the samples recorded at the end of the test ranged from 6.38 to 6.97, indicating (from Table 1) that GI pipes would not be recommended in four of the boreholes and have limited suitability in the fifth. In three of the boreholes the initial filtered iron concentrations, which varied from 21 to 26 mg/l, had reduced to between 0.5 and 0.17 mg/l by the end of the test. In the remaining two boreholes, the initial iron concentrations were lower at 4.5 and 1.17 mg/l and these had reduced to 0.86 and 0.48 mg/l respectively by the end of the test. The sharp decline in iron concentration in the samples is illustrated graphically on Figure 4.

Figure 4. Results of laboratory tests on samples from pumps with GI risers

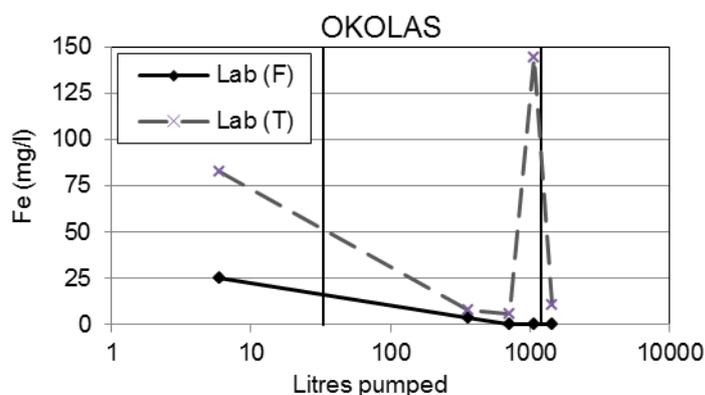
When the results from filtered and unfiltered samples were compared it was apparent that filtered samples generally had a lower iron concentration, for example at the Okolas borehole (Figure 5). This may be due to solid corrosion products being removed by filtration, but also to removal of any iron that had precipitated in the short period between sampling and filtering. Nevertheless, the filtered samples clearly show the rapid fall in iron concentration attributable to the removal of iron present due to corrosion of the handpump.

The unfiltered samples from Okolas also show a sudden increase in iron concentration after about 1,000 litres had been pumped, corresponding with an increase in turbidity during pumping. This illustrates how concentrations can be anomalously large if solid corrosion products are present in an unfiltered sample.

Figure 5. Comparison of laboratory analysis on filtered and unfiltered samples

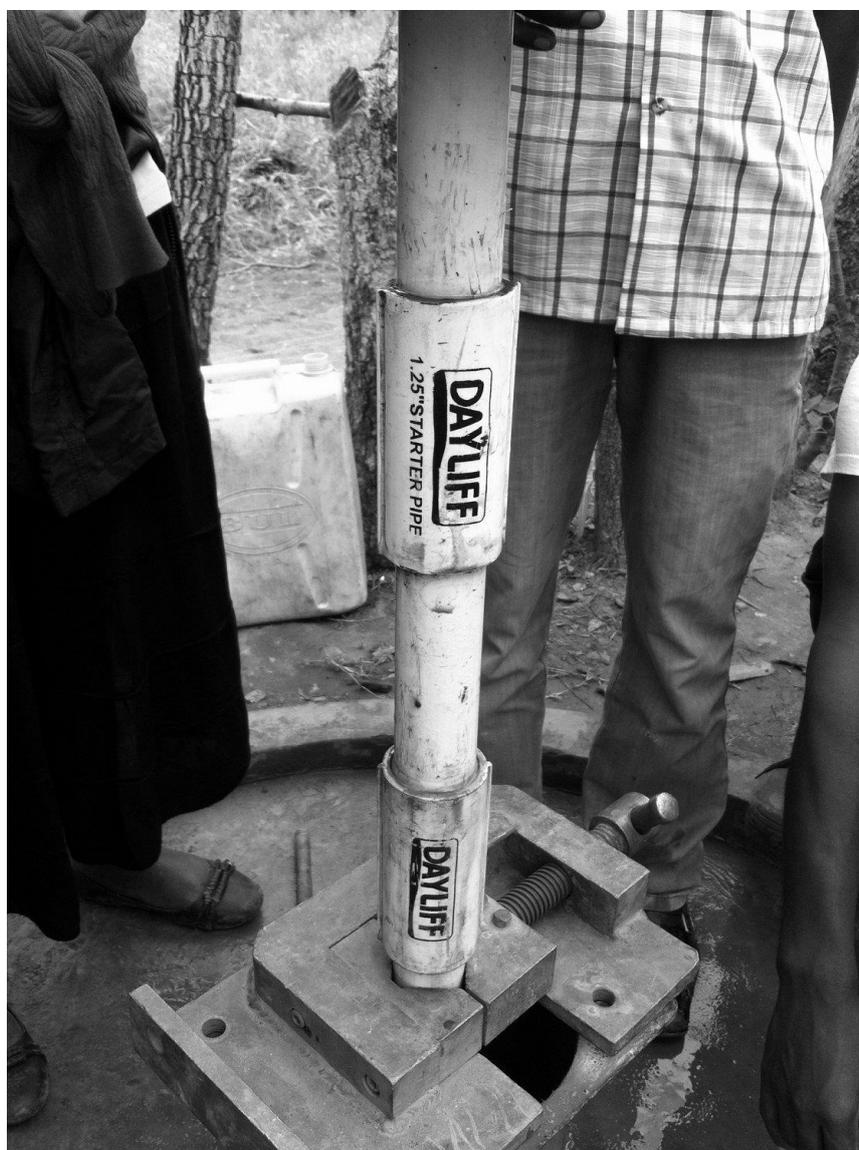
The third borehole at Angodingod (Figure 6) was a U2 fitted with 1¼" PVC riser pipe (supplied by Davies and Shirliff, Kampala) and GI pump rods. The Palintest results from two samples indicated iron concentrations less than 0.5 mg/l, confirmed by laboratory results of 0.06 mg/l. A pH of 6.2 was measured in the sample. Overall experience of this installation has been positive to date, and the community has reported an acceptable yield and an absence of coloured water in the early morning, as was the case with pumps with galvanised steel riser pipes.

Figure 6. 1¼" PVC riser pipe fitted to an India MkII pump at Angodingod
