Water Catchment management through a 3R approach- Case of RWAMBU Catchment-Western Uganda

Type: Short Paper (up to 2,000 words)

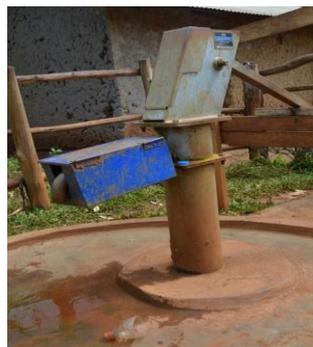
Pic 1: Recharged Borehole

1. **Increased water table:** This borehole in question was rehabilitated after so many years of non functionality due to low water tables. The 3R approach was integrated to Retain and Recharge water upstream so that it could be Re-used downstream. Indeed monitoring tests showed an increment of about 1.6m depth in ground water tables! The borehole that had never pumped water for years, now supplies the community with water throughout the year. This technology created employment for the caretaker who is paid 10% of the proceeds, O&M Improved and community started perceiving water as an economic good. When this borehole is compared to a similar one about 10km away, the other one still dries up at some seasons of the year. If this case is taken as a control, it is a sure way to think that the 3R interventions are a success for Rwambu

- The water table is stabilising, and the water recharge rate for boreholes and shallow wells is adequate as evidenced by an increase in water table for a shallow well in Kinagamukono village from 37m to 34.6m (2.4 m rise), yield at 0.51m³/hr, draw down at 21.51m, dynamic water level after 120 minutes at 56.40m.

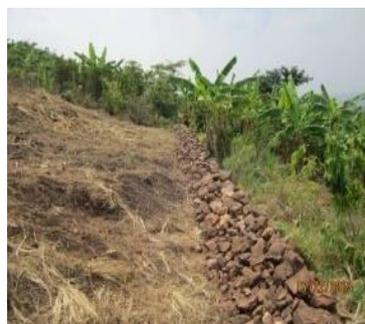
Pic 2: Stone Piles

2. **Stone lines:** This labor intensive intervention is worth the effort. The once abandoned infertile land regained its productivity. Communities which had resorted to encroaching on the wetland in search for fertile land downstream, once again started cultivating on their previously infertile hill slopes. This intervention checks soil erosion and improves soil depth by creating “soil benches” allowing time for water Retention and Recharge.

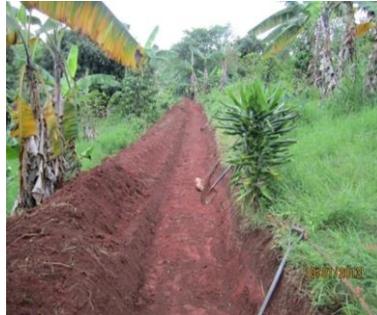
Pic 3: Fanya Chini

3. **Fanya chini:** Fanya Chini” is a word from the Kiswahili dialect to mean “working down” This intervention is best suited in steep slopes. The soil dug from the trench is thrown on the lower side of the slope as opposed to its counterpart “fanya Juu” to mean working up which is best suited in gentler slopes where the soil is dug and thrown up hill. Both are intended to check the speed of runoff and hence increase water Retention and Recharge.

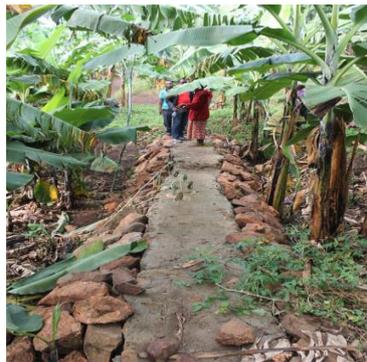
Pic 4: Check Dams

4. **Check dams:** This is a more permanent structure built of stone and concrete-the check dam. It was constructed to close up the V-shaped Gully that was created as a result of an advanced stage of soil erosion. Aside rehabilitating degraded hill slopes, it also reduces the speed of runoff hence, increasing water Retention and therefore encouraging water Recharge.
